# **EVALUATION OF USING ECC AND CFRP FOR STRENGTHENING OF CONCRETE STRUCTURES**

**September 2009**

Thesis submitted to the United Graduate School of Agricultural Sciences for  
partial fulfillment of the requirements of the

Degree of Doctor of Philosophy  
Production Environment Engineering – Concrete Technology  
Bioenvironment Science course

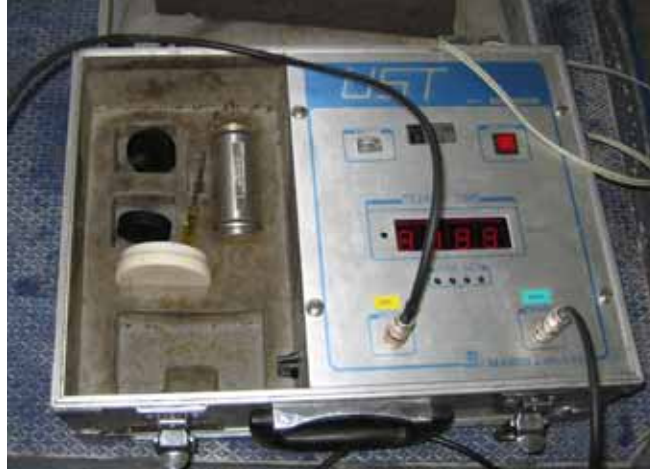
*Photo 2.1: UPV meter*

adopted to be placed as per one of the following combinations: 1) in opposite sides (direct measure), 2) along same side (indirect measure), or 3) in two perpendicular surfaces (semi-direct), of the specimen. Photo 2.1 shows the used UPV device.

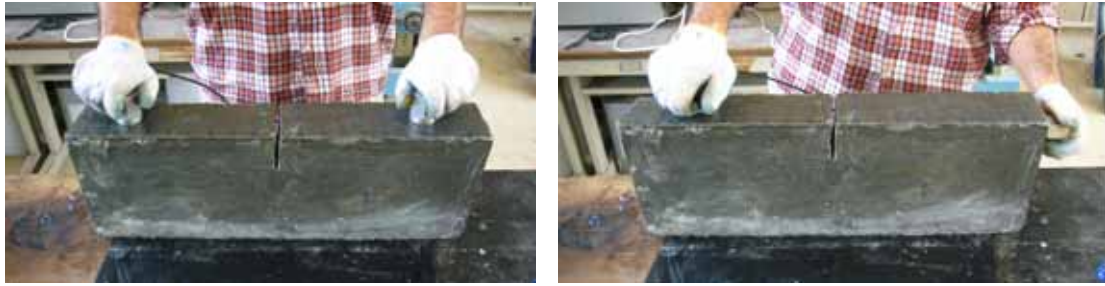
**Photo 2.2 a): Indirect transmission and, b): Semi-direct transmission for UPV test**

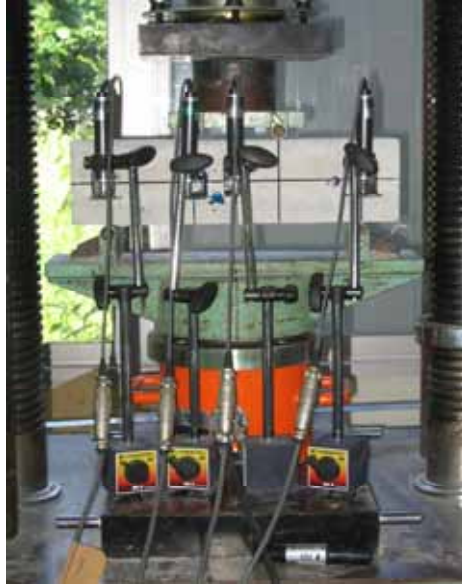
*Photo 3.1: Typical loading configuration*

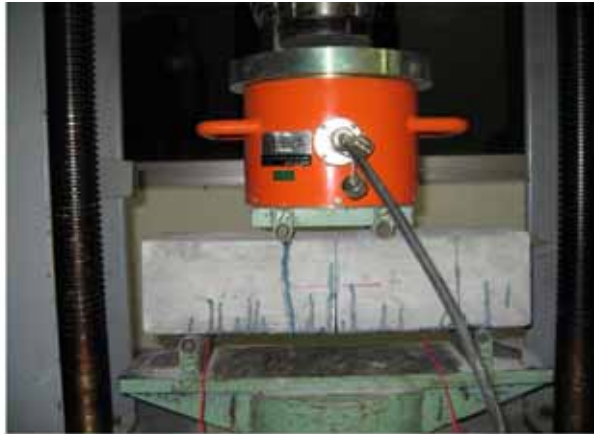
*Photo 3.4: Typical indirect tension test configuration*

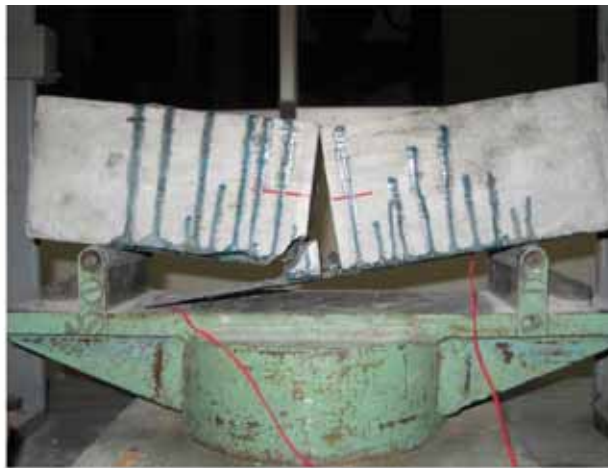
*Photo 3.5: Interfacial debonding in case of concrete substrate*

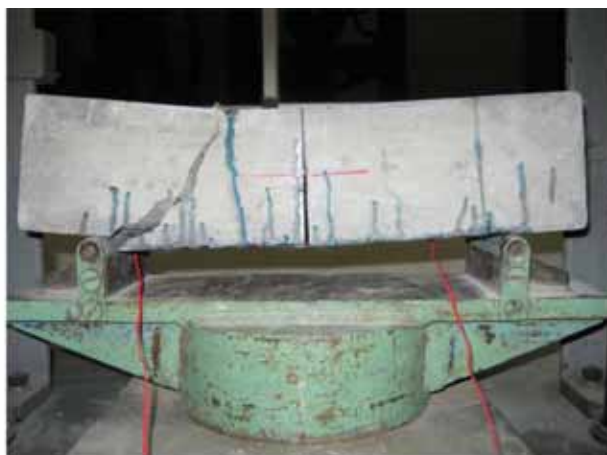
*Photo 3.6: Shear failure in case of ECC substrate*

The observed diagonal tension failure occurred in case of ECC revealed that the bonding strength between CFRP and ECC substrate was even higher than the tensile strength of ECC. The brittleness of concrete did not allow compatibility in the deformation between the CFRP sheet and the concrete substrate; this consequently led the lower corner edge of one of the concrete blocks to be broken followed by interfacial debonding failure. The longitudinal strains at the mid-span and at cut-off were measured and shown in Figure 3.4. It was also noted that the ECC assembly failed in a load value higher than that of concrete (38% more than concrete).

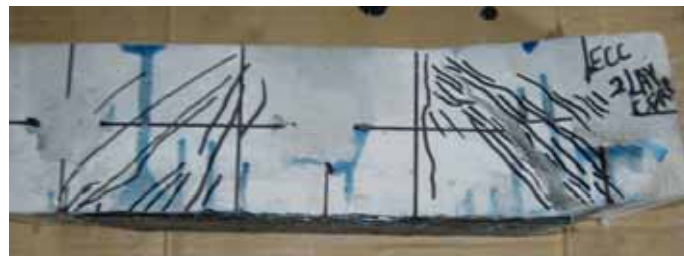
**Photo 3.7: Shear failure mode for ECC beam strengthened with CFRP**

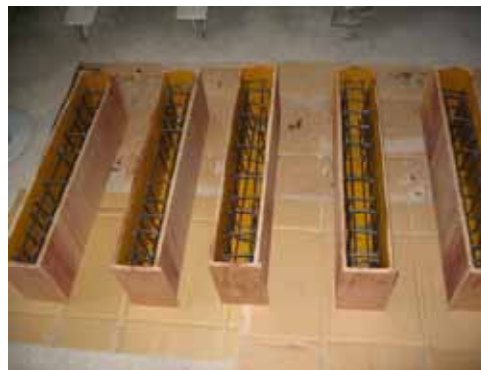
**Photo 3.8: Moulds containing the reinforcement of concrete beams**

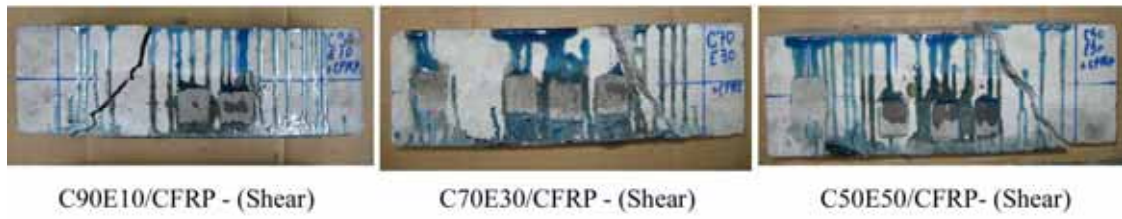
***Photo 3.9: Modes of failure for small specimens***

Finally, it can be said that ECC worked as a transition layer between the concrete beam and the external CFRP sheet. The high ductility of ECC allowed compatibility in the deformation of the brittle concrete and the elastic CFRP. ECC deformed with CFRP smoothly and minimize the probability of the interfacial debonding failure or even prevented it. It was noted that for effective strengthening, ECC should extend beyond the main reinforcement to approximately a distance at least equal to double the main reinforcement cover depth. The modes of failure for all the examined beams are shown in Photos 3.9 and 3.10 for small and big beams, respectively.

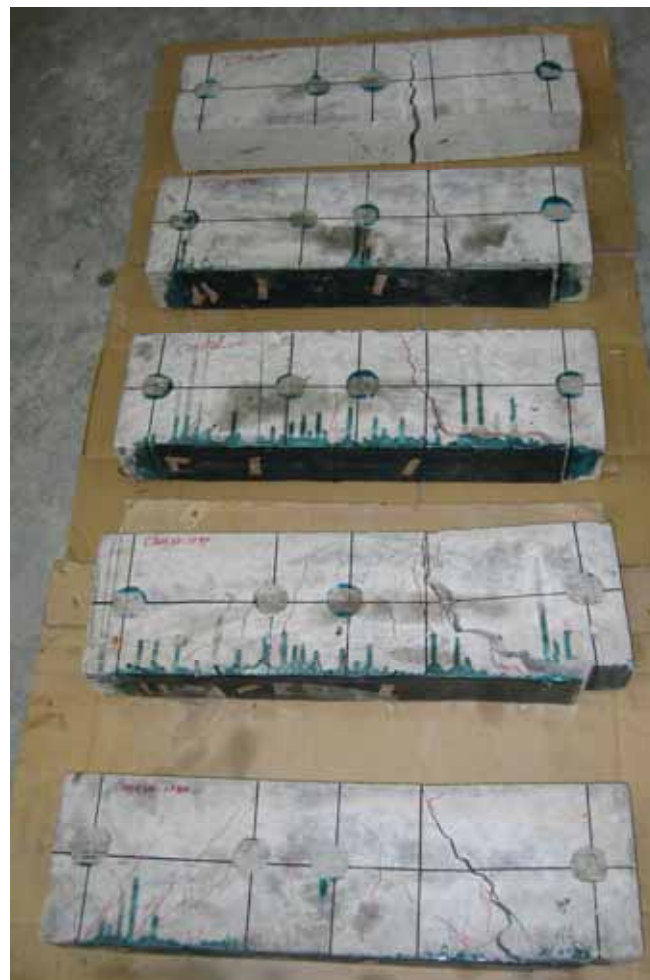
***Photo 3.10: Modes of failure for big specimens***

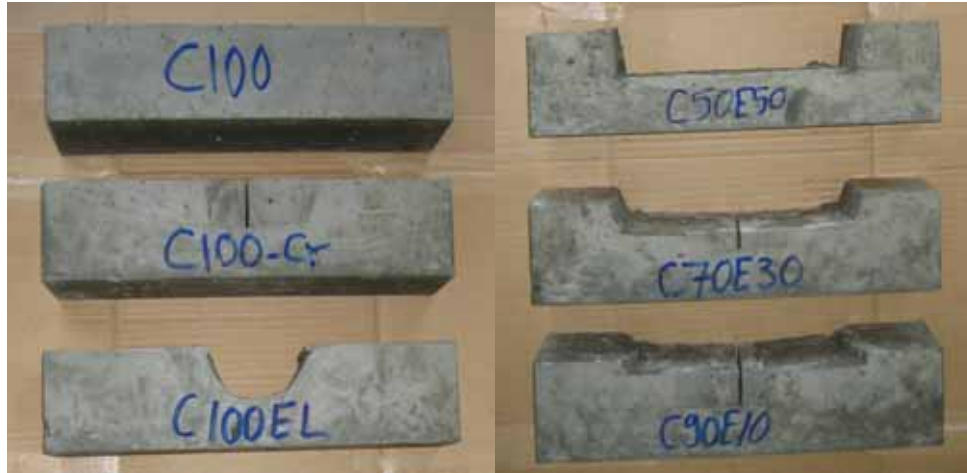
**Photo 4.1: Specimens before repair**

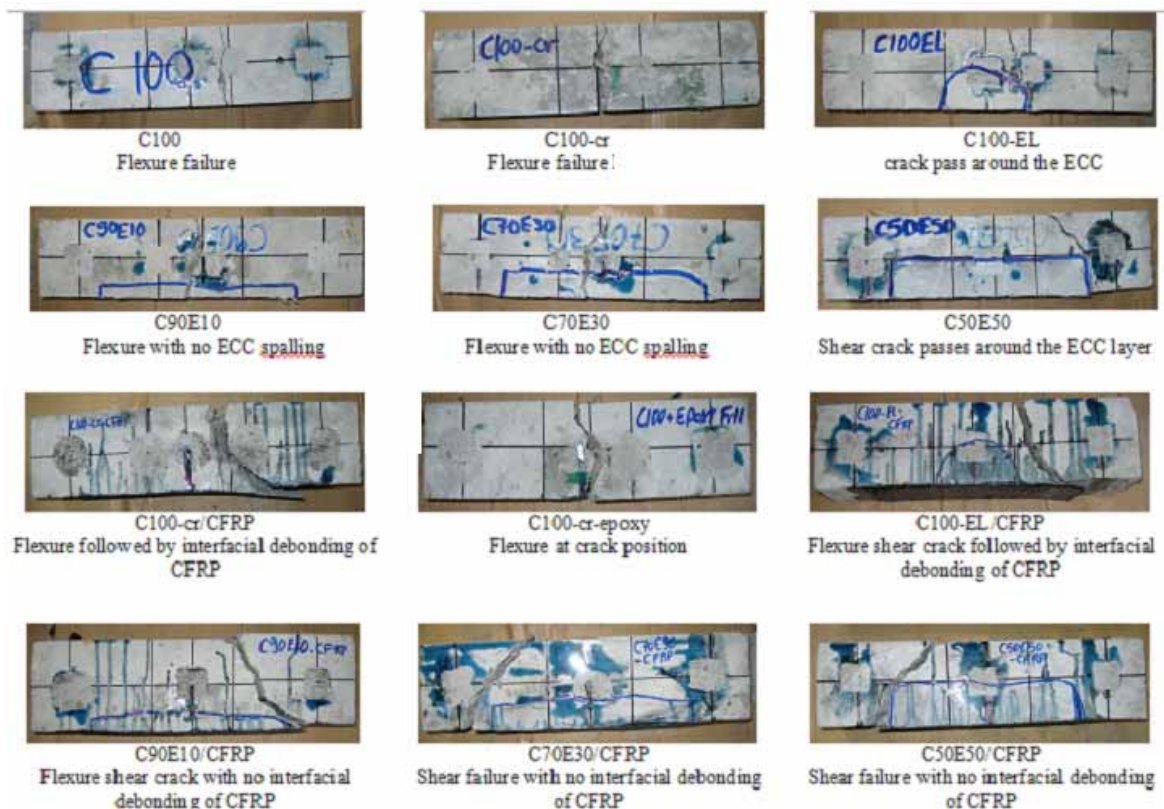
*Photo 4.2: Typical Modes of failure for the examined specimens*

In contrast with concrete, for all the other specimens where CFRP was applied over the ECC layer with different thicknesses, the common interfacial debonding of CFRP was changed to shear failure. Flexure shear crack was observed in case of (C90E10-cr/CFRP) while (C70E30-cr/CFRP) and (C50E50-cr/CFRP) underwent a pure shear mode of failure and the crack was found extending from the support directly to the loading point. The shear crack split the concrete near the support leaving a small portion attached to the ECC layer. Moreover, it was noted that 30 - 50% reduction in the effective shear resisting cross-section for both (C70E30/CFRP) and (C50E50/CFRP), respectively, was behind the observed pure shear failure. This emphasizes the great influence of ECC on delaying the interfacial debonding failure or even preventing its occurrence. It was thought that if the beams were well confined in shear, the previous trends might have little changes. Moreover, it might be expected that the interfacial debonding would have happened but after achieving higher loading value. The reasons for the strong bonding between ECC and CFRP was mentioned in details in the previous chapter and was attributed to the ability of ECC to develop very high strain comparing to concrete; along with the small size cracks that were created in case of ECC. The previous reasons might lead to minimize the induced shear stress in the adhesive layer and decelerated the debonding failure.

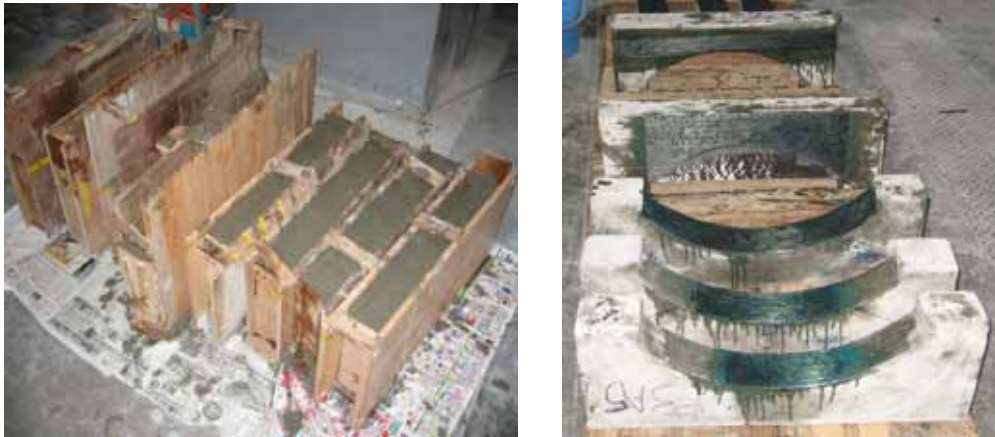
*Photo 5.1a): Moulds after casting, and b): after pasting CFRP sheets*

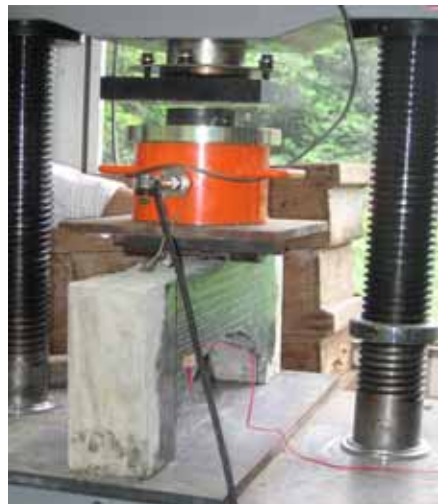
*Photo 5.2: Typical test setup*

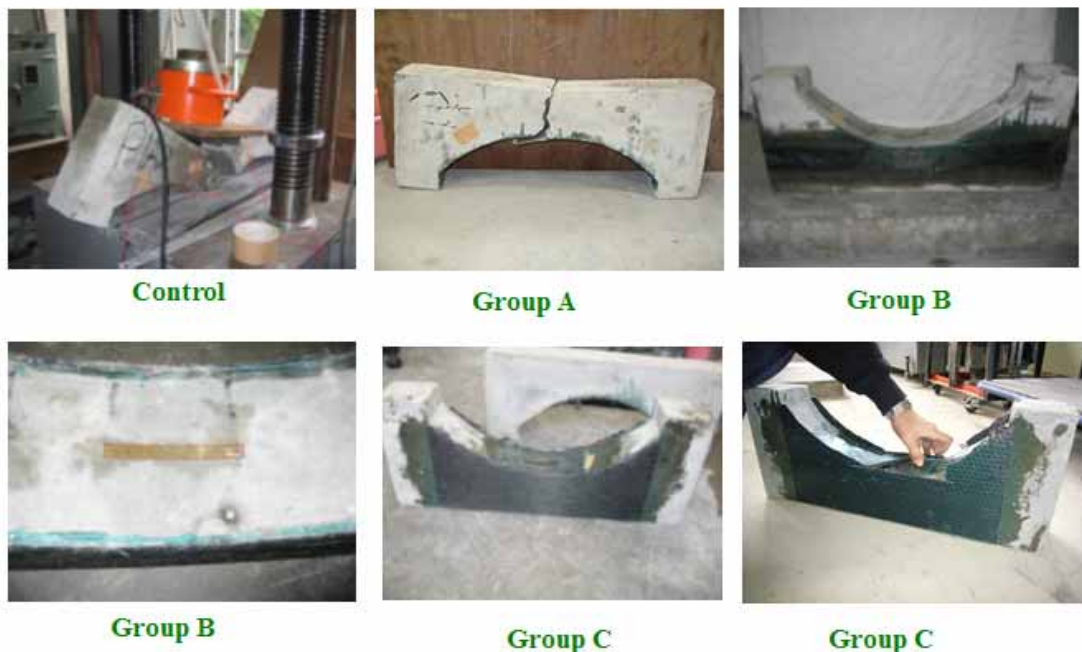
*Photo 5.3: Modes of failure for the examined arch specimens*

Group (A) appeared to have complete brittle failure behavior; the failure mode was triggered by the formation of flexure cracks in the mid-span that yielded extremely high stresses in the vicinity of the crack. The stress concentration along CFRP helped in delaminating of the CFRP sheet starting at the crack location and propagating in a very brittle manner towards the edges of the sheet. Moreover, it might be expected that the debonding in both S4 and S5 occurred faster, with lesser ultimate load, due to the tendency of the supports to deform laterally outside, and consequently stretching the CFRP sheet and pulling it downwards at the mid span.

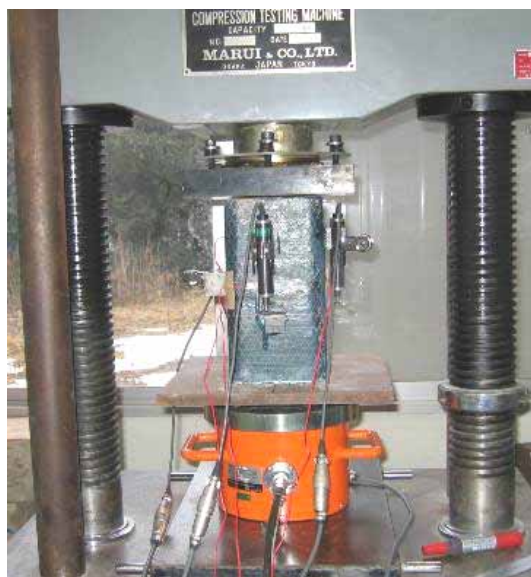
*Photo 6.3: Typical test setup*
