**Study on the Improvement of the Serviceability Performance
of Earth Hydraulic Structures by using High Performance
Fiber Reinforced Cementitious Composites**

**A thesis submitted in partial fulfillment of the requirement of Doctor of
Philosophy Degree**

Water Supply Engineering

**Water Supply Facilities Laboratory
Production Environmental Engineering Division
Tottori University
Japan**

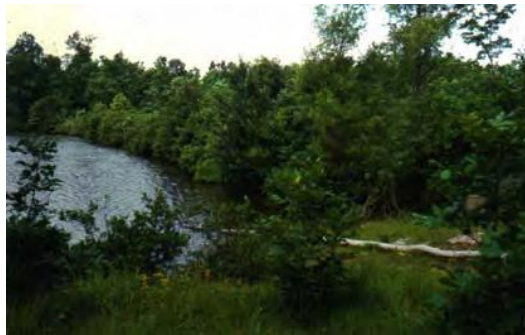
Fig.2.1.Dam with inspection-hindering trees in Tennessee[6]

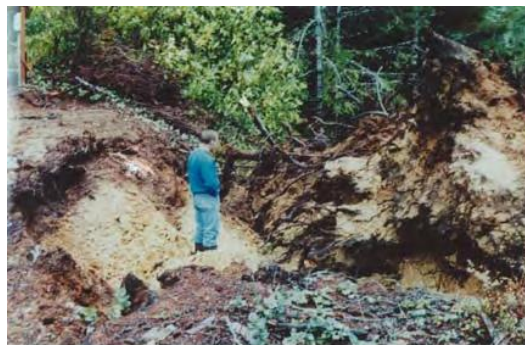
Fig.2.2.Serious damage by uprooted tree to embankment stability at a dam in Oregon[6]

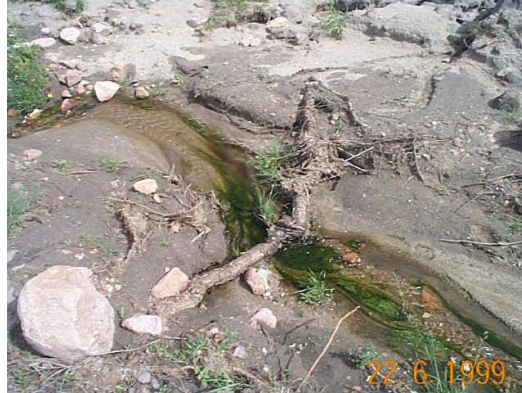
Fig.2.3.Dam failure due to root penetration in Colorado[6]

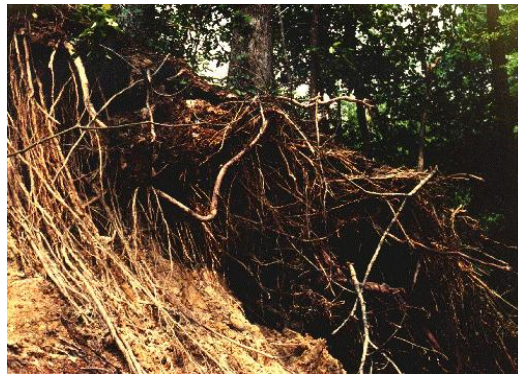
Fig.2.4.Exposed tree roots in overtopped dam[6]

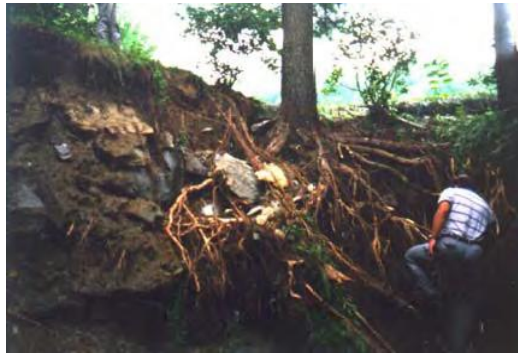
Fig.2.5. Tree root induced scouring on crest and downstream face[6]

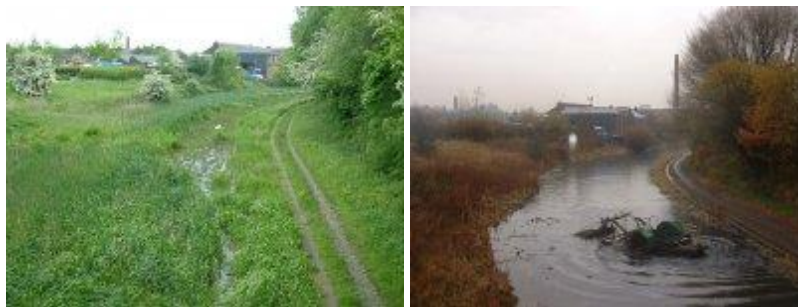
Fig.2.6.Manchester Bolton and Bury Canal- The photo on the left shows the original overgrown state of the canal and to the right the canal following clearance[80]

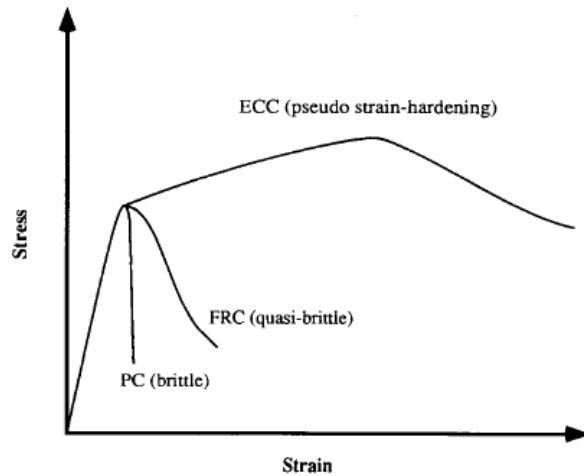
Fig.2.8 Different tensile failure modes in cementitious composites

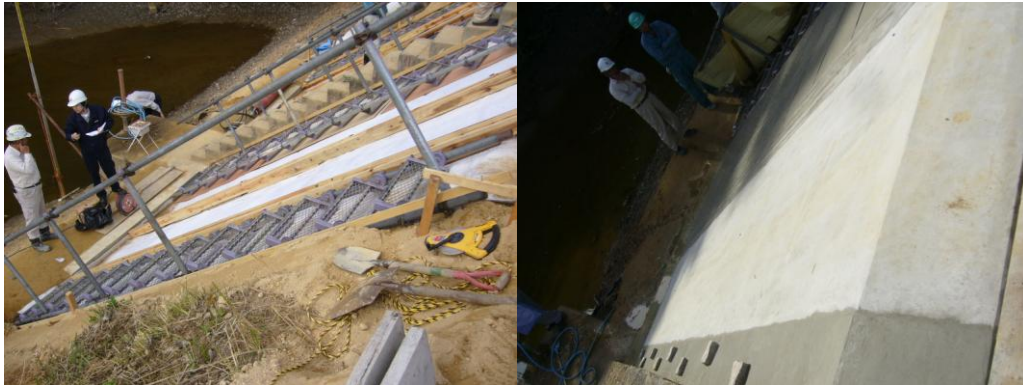
Fig 2.10 Earth dam repair with ECC in Tottori

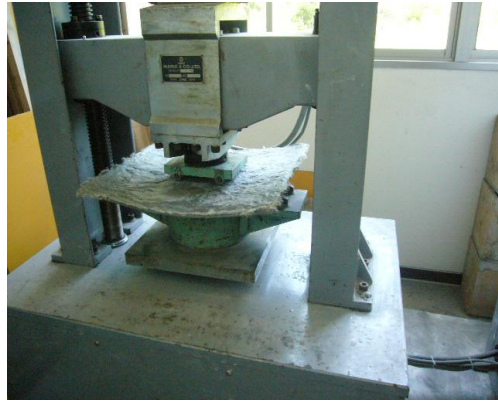
Fig.3.1.1.Generation of cracks using a bending machine

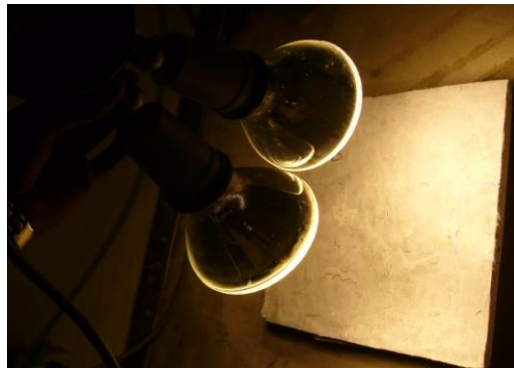
Fig.3.1.2.Illumination of an ECC plate by 2 tungsten bulbs, each with wattage of 150W

room, with all external light sources eliminated. Each test plate was placed on a platform and illuminated by 2 tungsten bulbs, each with wattage of 150W (Fig.3.1.2).Luminance readings were read from the light meter placed below the plate. Three readings were taken on each plate to determine its average luminance. The average luminance from the 3 plates in each set was then used to obtain the average luminance for the set.

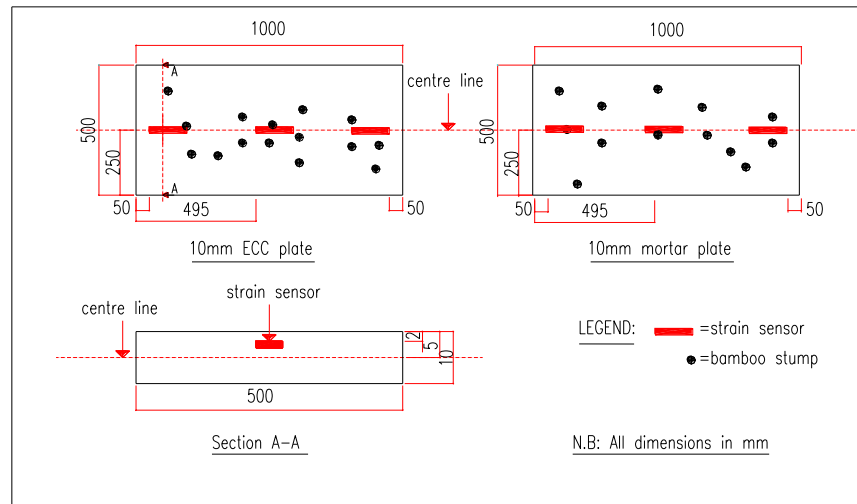
Fig.3.1.5.Schematic diagram of ECC and mortar plates showing bamboo stumps and strain sensor positions

The *Sasa Senanensis* was mowed and stumps leveled to the ground. Fresh ECC and mortar was cast over the bamboo stumps into plates of dimensions 1000mm x 500mm x 10mm. The surface dimensions were selected to allow a significant number of bamboo stumps to be covered (average 15 stumps). The plates were embedded with 3 strain sensors along the middle strip (250mm from the 1000mm edge, Fig.3.1.5). The right and left sensors were embedded 50mm from the 500mm edge. The 3rd sensor was embedded 495mm from the 500mm edge. All sensors were embedded 2mm below the surface of the plates as shown in section A-A in Fig.3.1.6. Steel anchors were used to fix the plates to the ground. Strain readings were collected from the sensors periodically for 6 months using a digital strain meter TC-31K. Visual inspections were concurrently carried out on the plates.

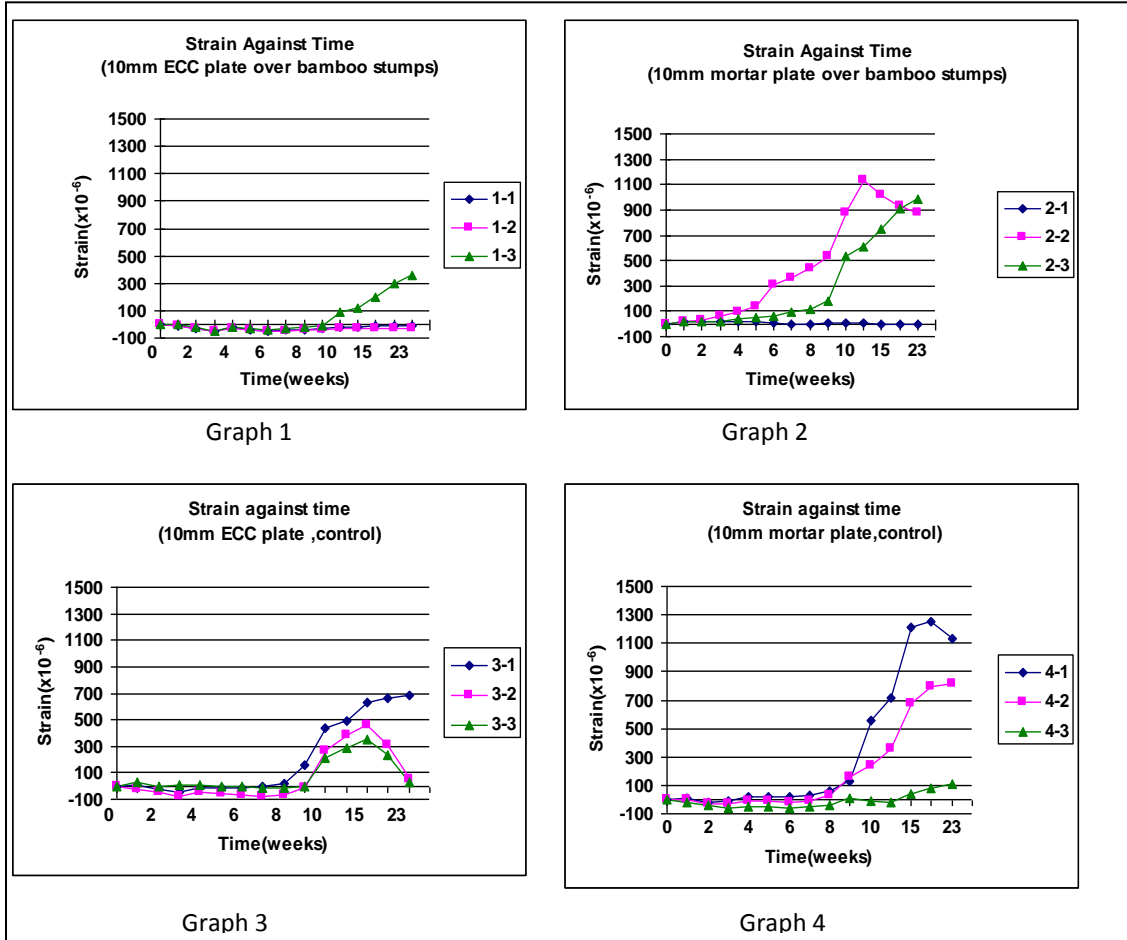
Fig.3.1.7.Graphs of Strain (x10⁻⁶) against time (weeks) for 10mm ECC and mortar plates

The bamboo shoots emerged from the soil around the ECC and mortar plates 21 days after casting .The variation in height of the shoots B-1, B-2 and B-3 from the control stumps is shown in Fig.3.1.6. Neither shoots nor visible cracks were observed on top of the plates. The variation of strain with time for the ECC and mortar plates is shown in Fig.3.1.7. Each graph represents results from the 3 strain gauges on a particular plate. The location of the gauges within the plates is schematically shown in Fig.3.1.5. Graphs 1 and 3 represent the results from plates 1 and 3 which are the ECC test and control plates respectively. Graphs 2 and 4 represent the results from plates 2 and 4 which are the mortar test and control plates respectively. Each line on the graph represents readings from a particular strain sensor in a plate. The left, middle and right sensors are denoted as sensor 1, 2 and 3 respectively. The strain sensor is therefore denoted by 2 digits *x-y*. The left digit(*x*) represents the plate number and the right digit(*y*) represents the position of the sensor thus, line 1-2 represents readings from the strain sensor on position # 2 of plate # 1.

that of concrete. After the 4th week, the thermal strain, which is directly proportional to variations in temperature, caused the increase in strain in all the plates. The plates were cast at the beginning of April (spring) when temperatures were relatively low. The average temperature recorded on the plates using a thermocouple was 21⁰C in the 1st 4 weeks. The temperatures increased rapidly after 4 weeks (at the onset of summer) with average temperatures of 38⁰C being recorded. After 15 weeks temperatures began to decrease again (average 30⁰C) as fall approached. This trend in temperature is matched by the trend in the graphs in Fig.8 i.e. the increase in strain from the 4th week until the 15th week followed by a decrease thereafter.

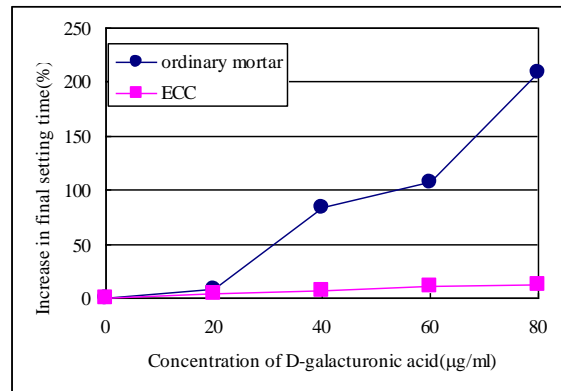
Fig.3.2.2.Rate of increase in final setting time of ECC and ordinary mortar due to D-galacturonic acid

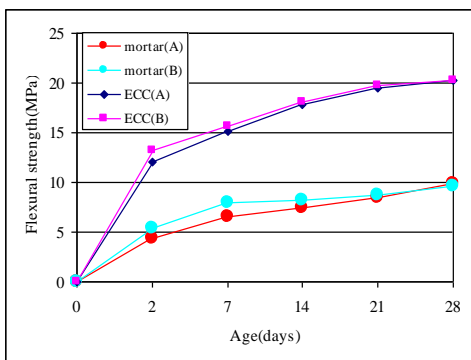
Fig.3.2.3.Flexural strength of ECC and mortar cured in acid (A) and water (B)

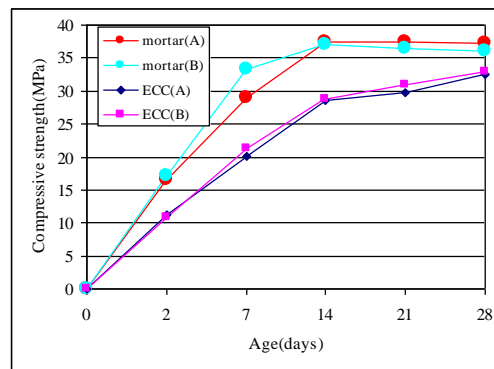
Fig.3.2.4.Compressive strength of ECC and mortar cured in acid(A) and water(B)

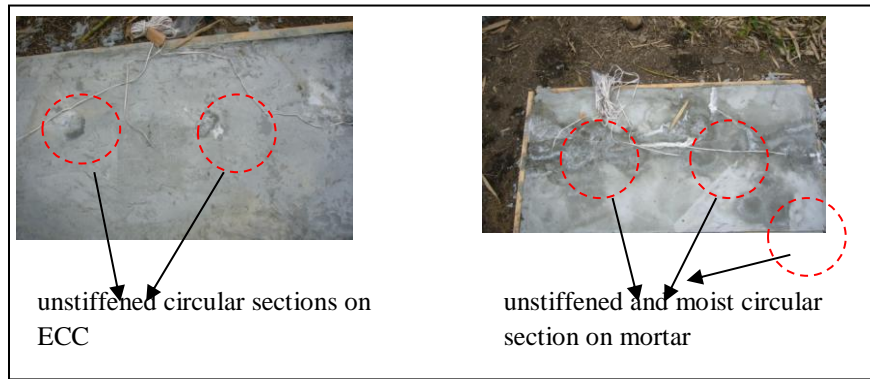
Fig.3.2.7. ECC and ordinary mortar plates 24 hours after casting

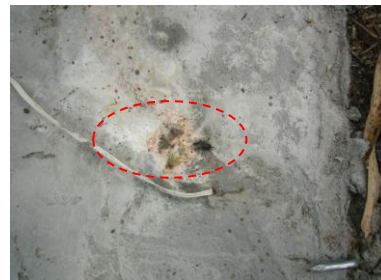
Fig.3.2.9. Disaggregated sand and cement on previously unstiffened patch on mortar 21 days after casting

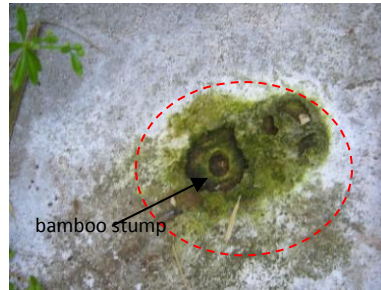
Fig.3.2.10.Circular hole on mortar plate
